Healey Dell Nature Reserve, Dell Road, Rochdale

An Archaeological Survey

This report presents the results of a programme of archaeological fieldwork carried out at Healey Dell Nature Reserve, Dell Road, Rochdale (NGR centred SD 8803 1613) by the University of Manchester Archaeological Unit (UMAU) and commissioned by Rochdale MBC.

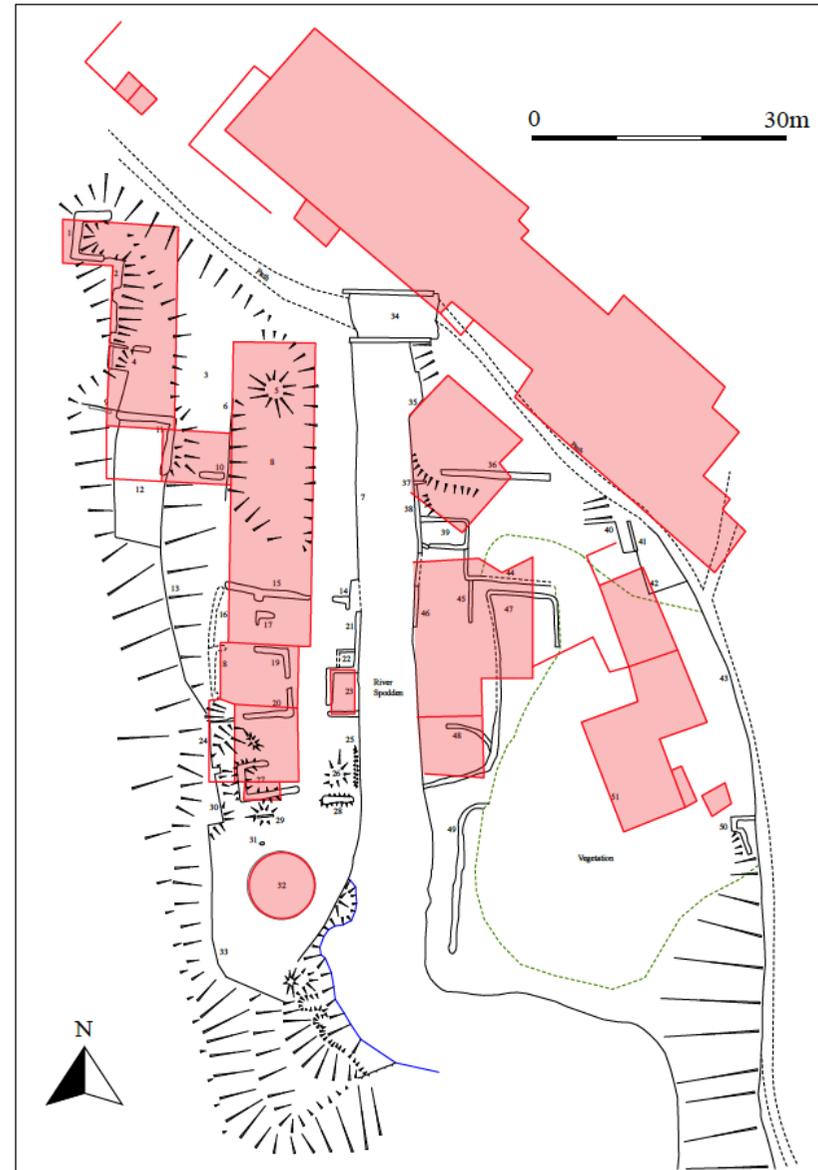
Fig 9: Broadley Mill measured survey with extent of mill buildings as shown on the 1890 1:2500 OS map (overlaid in pink)

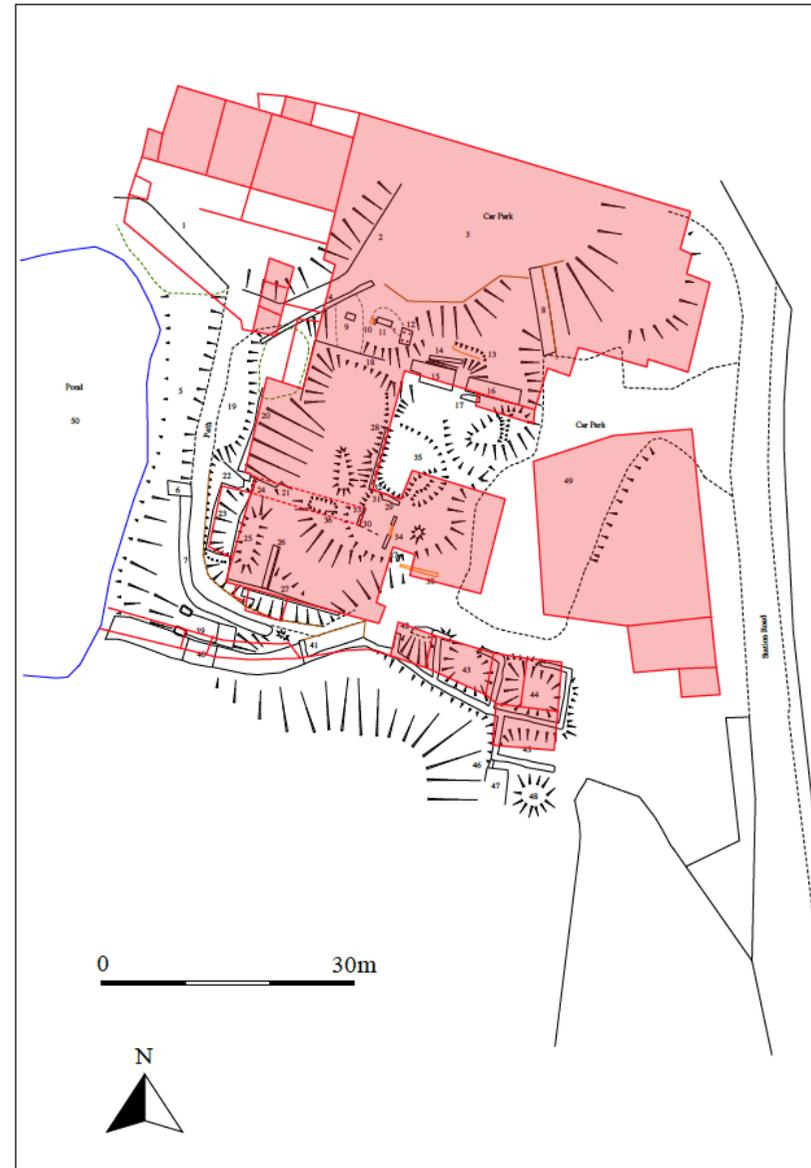
Fig 10: Broadley Wood Mill measured survey with extent of mill buildings as shown on the 1908 1:2500 OS map (overlaid in pink)

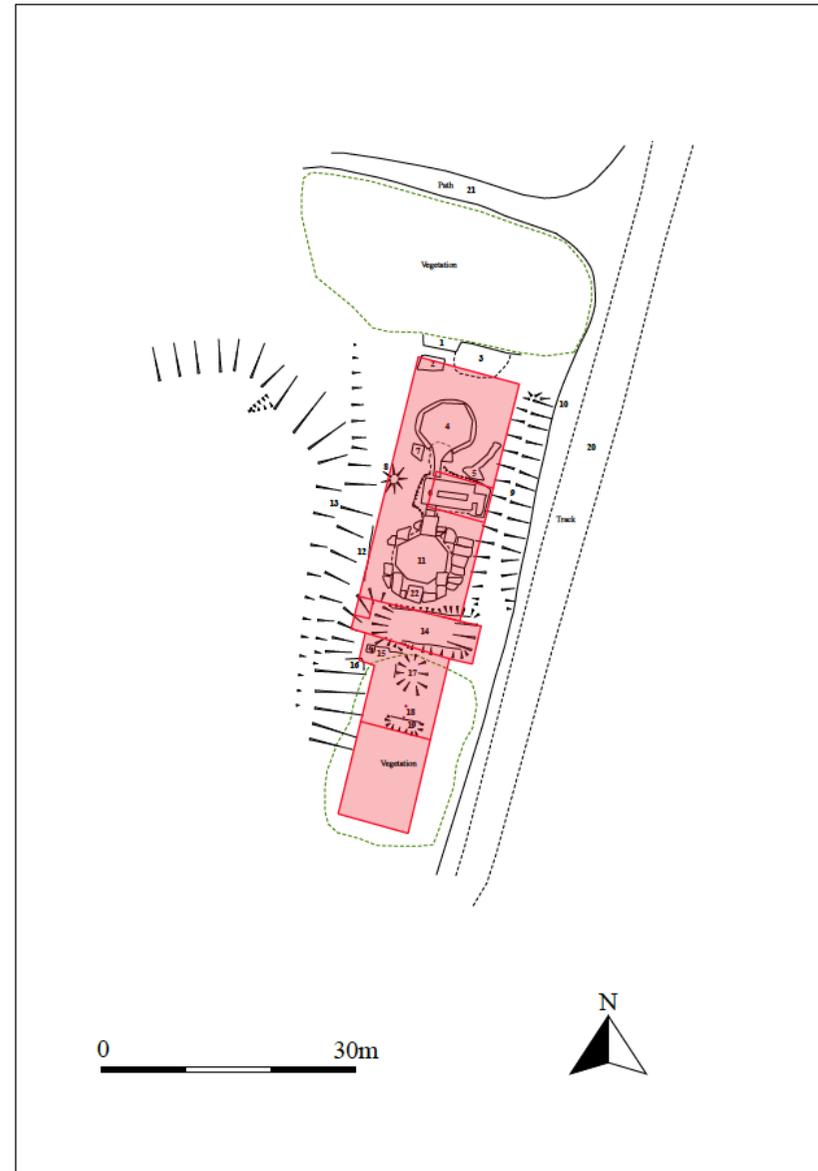
Fig 11: Broadley Stone Rubbing Mill measured survey with extent of mill buildings as shown on the 1908 1:2500 OS map (overlaid in pink)

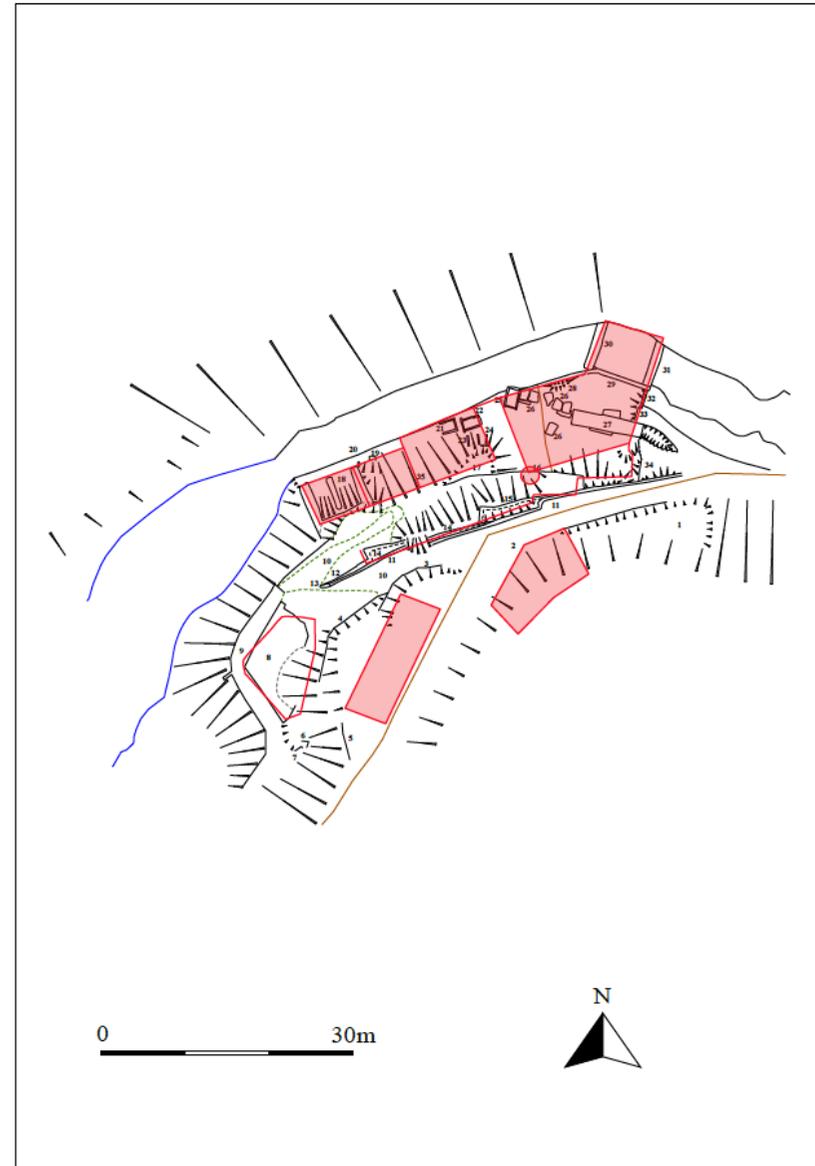
Fig 12: Th'Owd Mill I't Thrutch measured survey with extent of mill buildings as shown on the 1844-8 6" and 1890 1:2500 OS maps and other documentary sources (overlaid in pink)

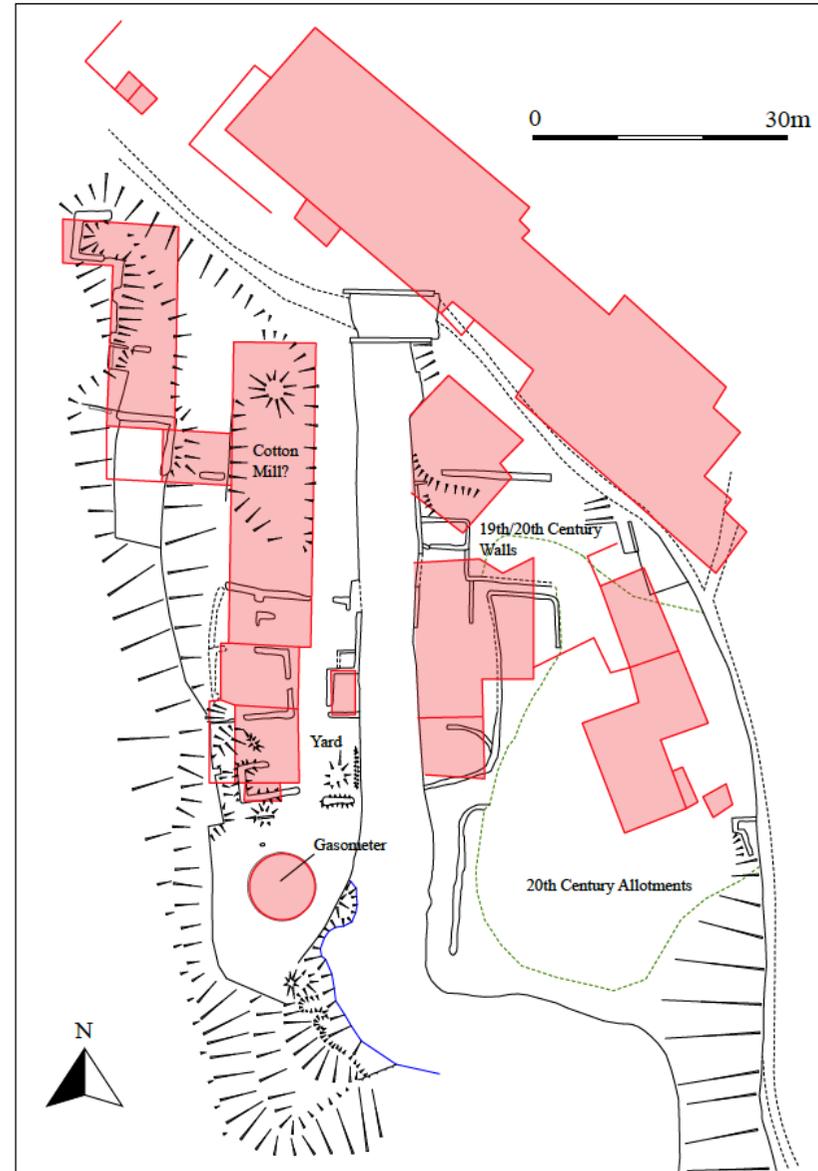
Fig 13: Broadley Mill measured survey with current interpretation

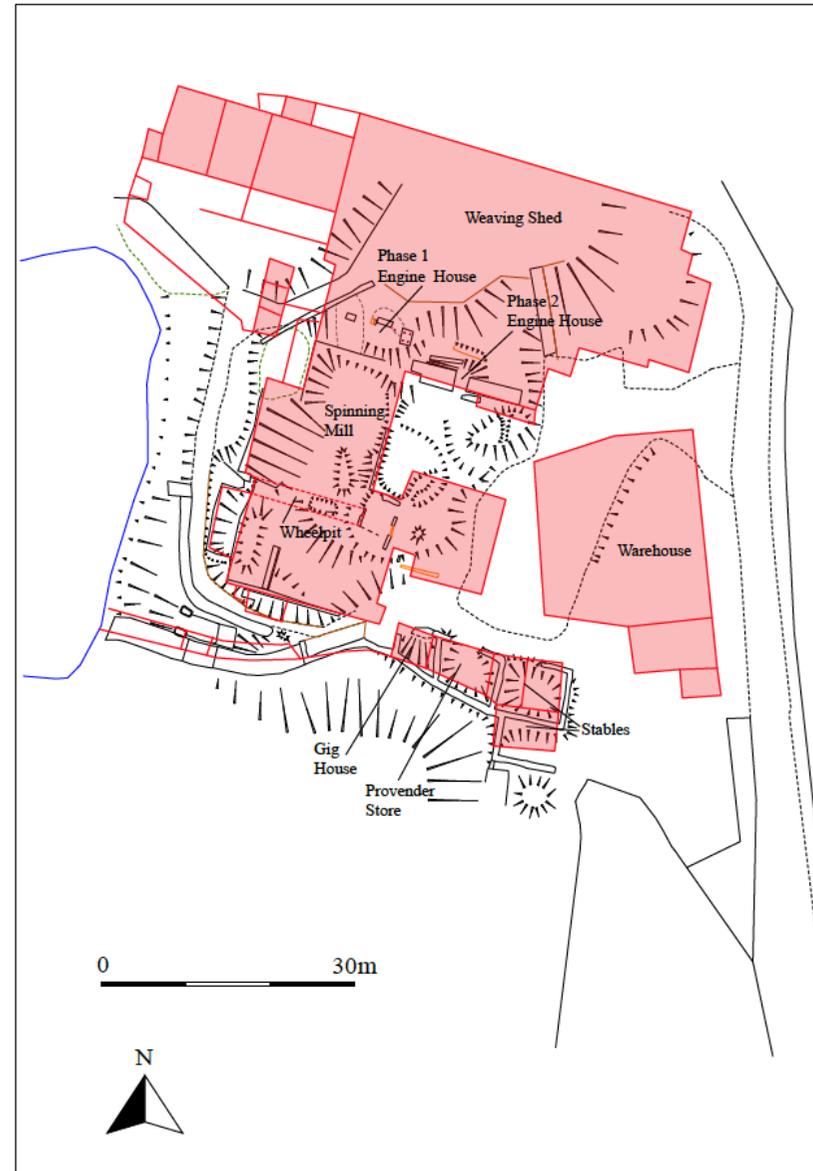
Fig 14: Broadley Wood Mill measured survey with current interpretation

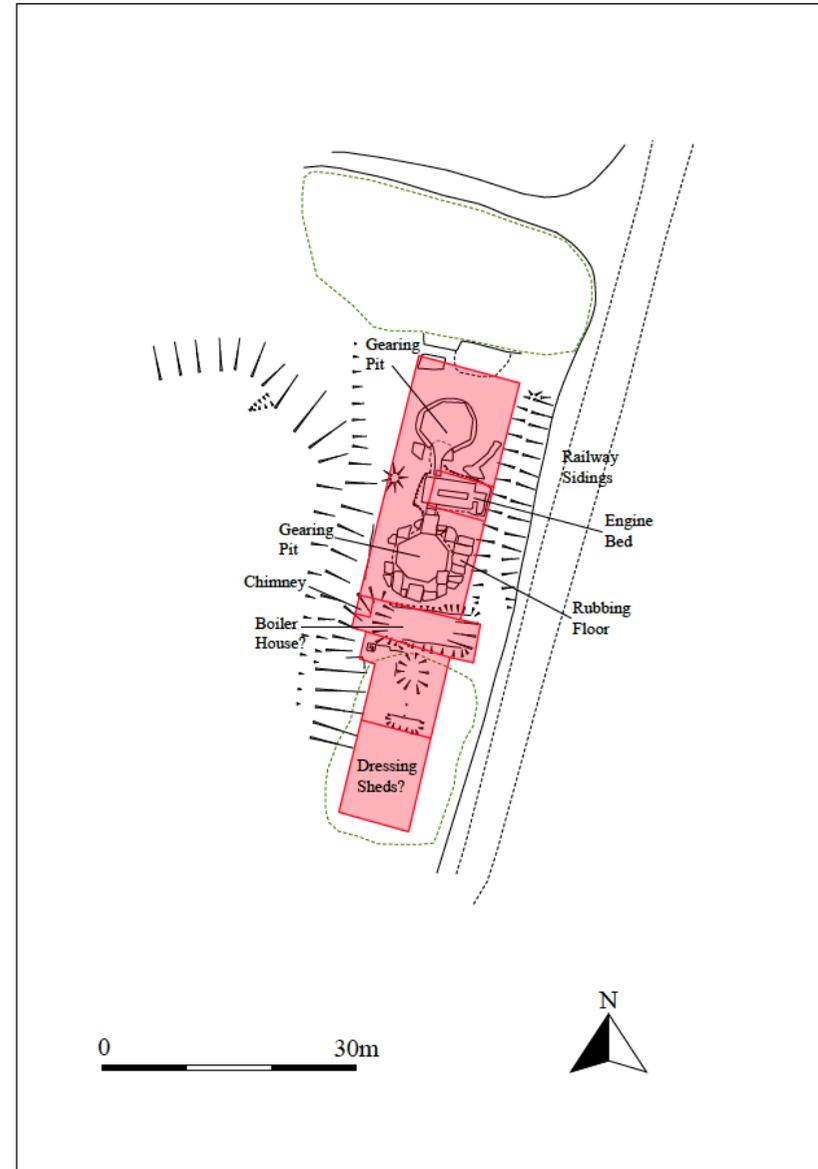
Fig 15: Broadley Stone Rubbing Mill measured survey with current interpretation

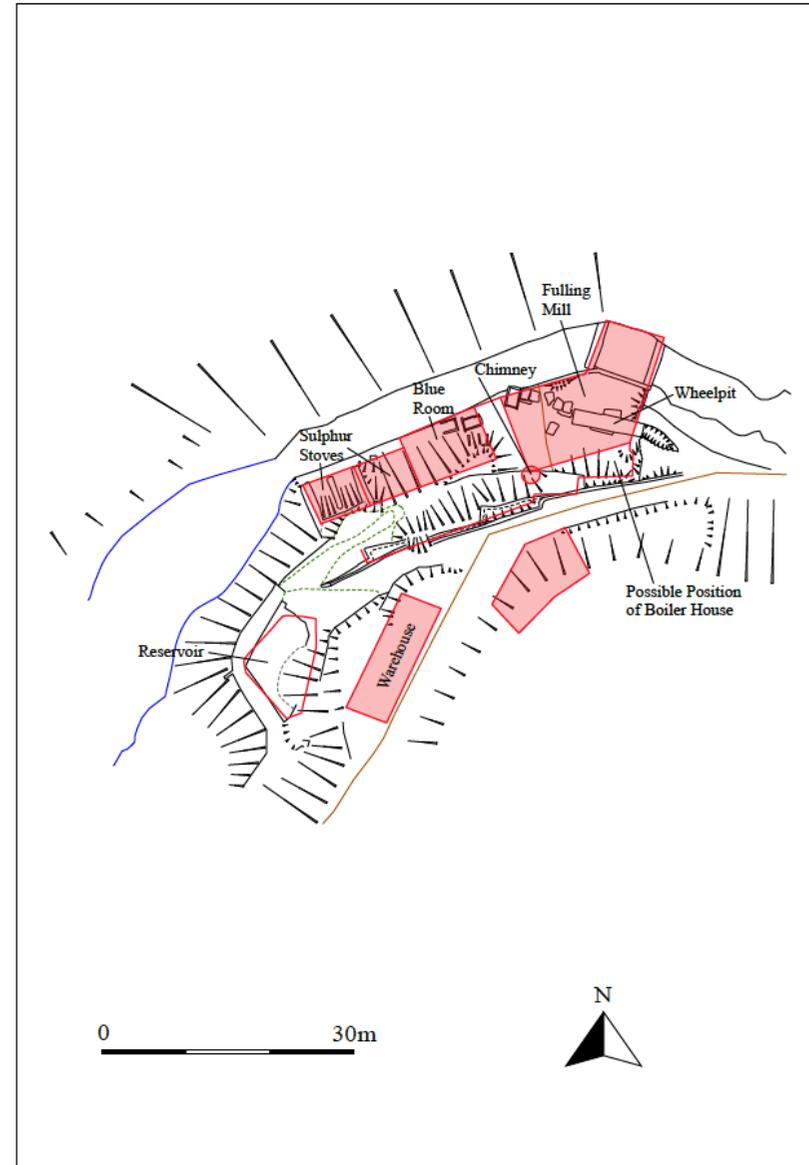
Fig 16: Th'Owd Mill I't Thrutch measured survey with current interpretation
