CATLEY LANE HEAD

CONSERVATION AREA APPRAISAL

November 2017

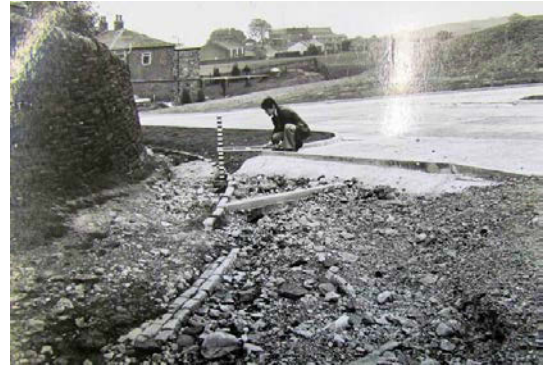
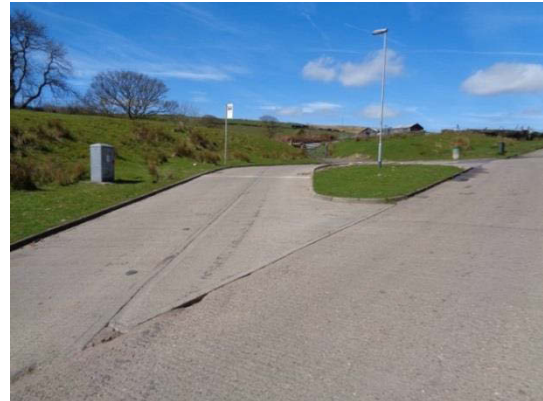
In the 1980s the Council improved Rooley Moor Road and constructed a bus turning circle just to the North of Catley Lane Head.

Construction of the bus turning circle in 1982 and the circle in 2016

- Creating a bus stop/turning circle that uses traditional materials
- Replacing patches of tarmac on the Cotton Famine Road with setts
- Reinstatement of historic materials
- Restoration of derelict buildings

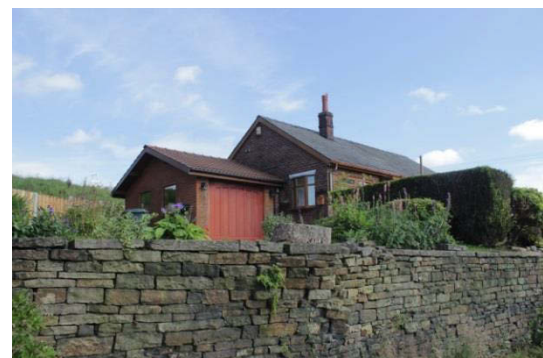
25 Smallshaw Road stands out as the red brick walling is out of character with the local vernacular materials.

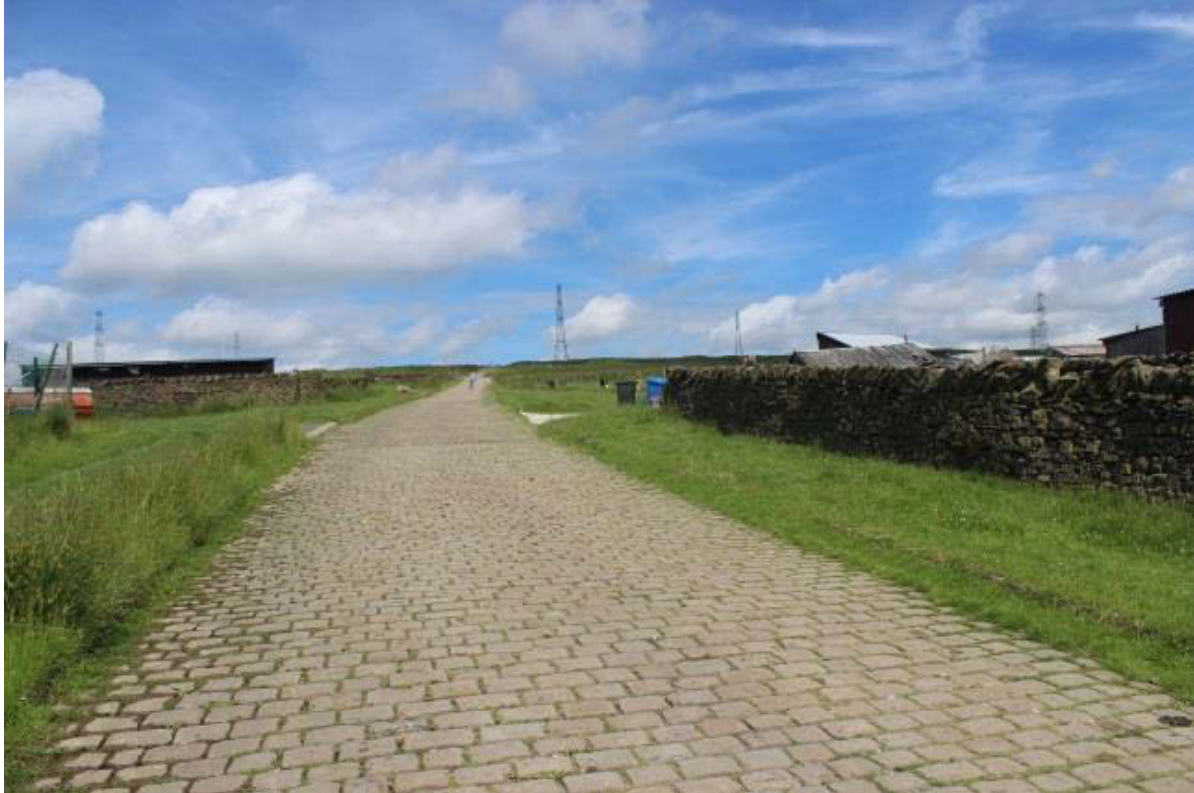
A section of the Cotton Famine Road

To the north of the hamlet, beyond the cattle grid and bus turning circle, lays a long setted section of Rooley Moor Road with stone kerbs and drainage channels at the sides. The width of the setted road from the Ding Quarry entrance to Catley Lane Head varies from 4.5m to 5.5m with the number of setts across the road varying from 12 along the narrow sections to 24 at Catley Lane Head. By averaging the width of the road, the total number of setts has been estimated at 327,600.

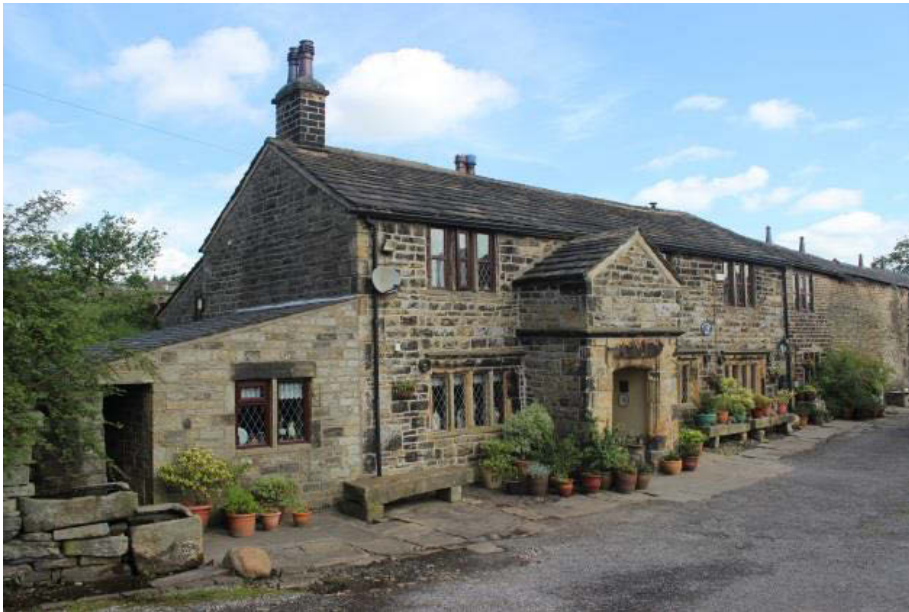
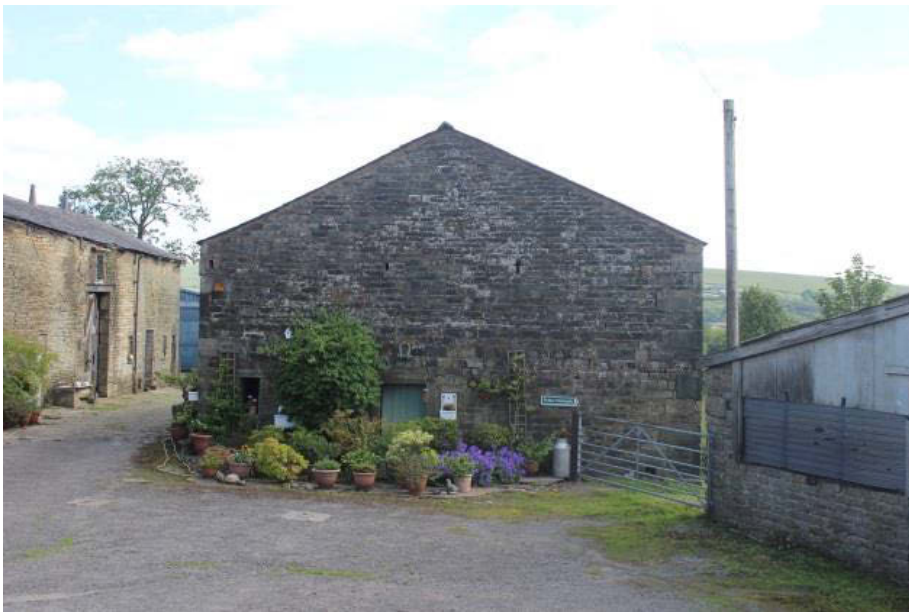
Smallshaw Farmhouse

This Grade II listed building is built on a three unit plan with a projecting two storey porch, a rear wall fireplace and chimney stack and a 20th century lean-to addition to the left gable. It retains windows of 4 lights (now 2), 6 lights and 4 lights with recessed ovolo-moulded mullions, and hoodmoulds with spiral stops. The central window has a king mullion. The upper floor has flat-faced mullions of 3, 4 and 3-(with mullions removed) lights. The porch has a moulded door opening with inscribed lintel (1622 ICM.....H) and slightly overhanging upper storey separated by a moulded band. There is an attached barn with a full-height cart entry, stone paving in front of the house and associated farm buildings across the yard.

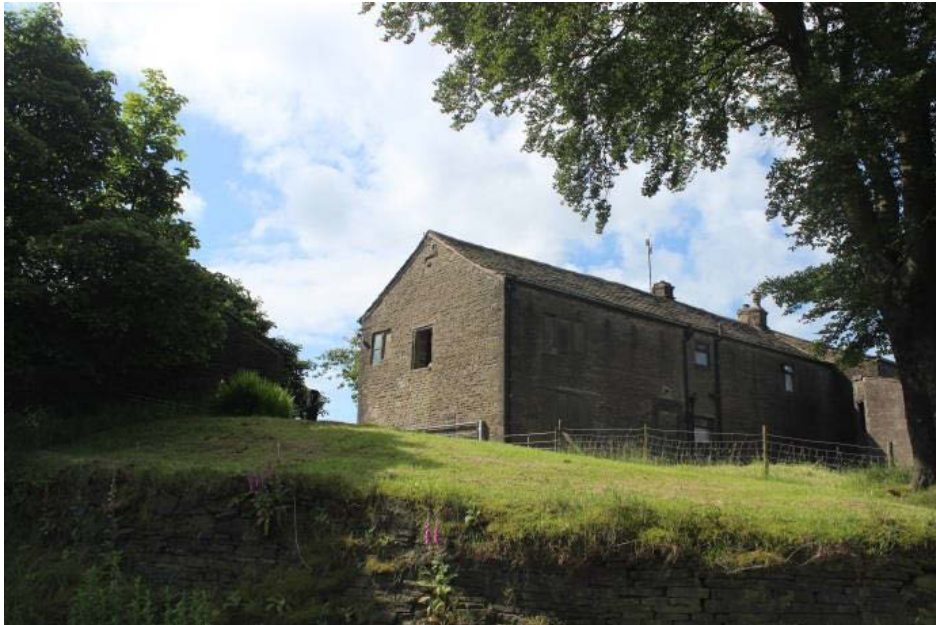
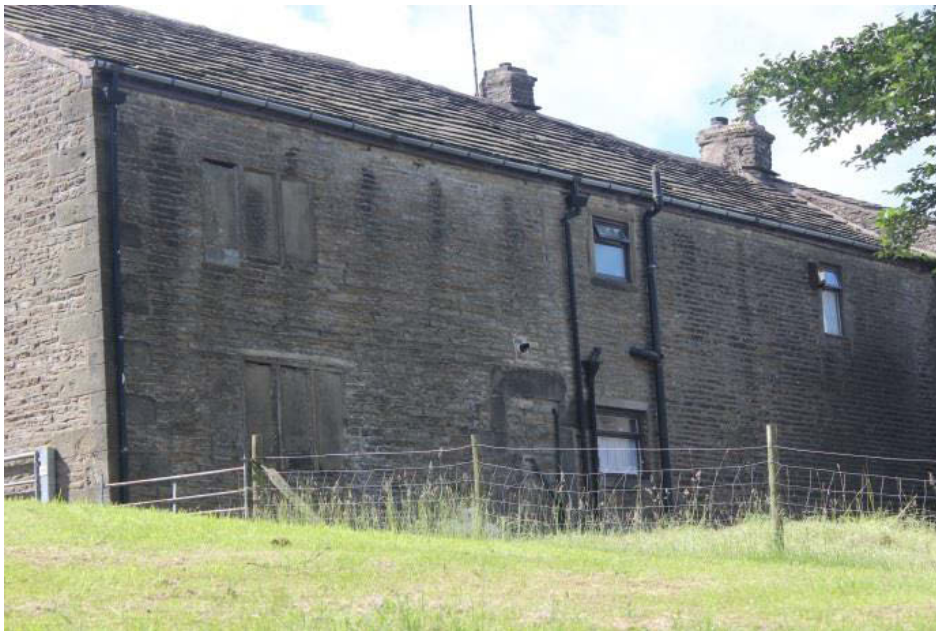
Brownhill Farm

Brown Hill Farm is a laithe house (barn and house under one long roof) with what appears to be an earlier wing which may date from the 18th century. This wing has two infilled 3-light mullioned windows and an infilled doorway with a stone surround of large blocks on the north elevation and a similar doorway on the south elevation. The wing has been converted to a barn and the house is now in the central section (Wetton, 2015).

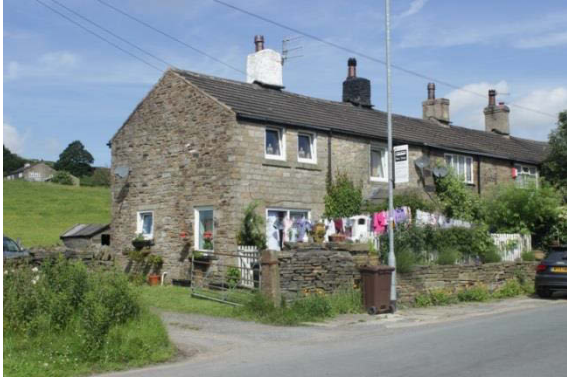
The hamlet itself contains a number of short terraces. Numbers 725-733 Rooley Moor Road are partly constructed from narrow coursed stone and may date from the 18th century. The rest are built of larger blocks and may be later; one retains a small stone outhouse built against the boundary wall. The short terrace opposite at 780-784 is dated 1848 and retains

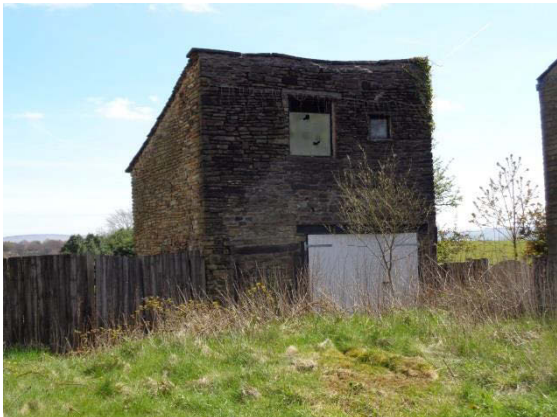
784 Rooley Moor Road

stone window and door surrounds and stone chimneys. To the north of number 784 is a two-storey building with a monopitch roof which may be a former workshop and retains two stone window surrounds on the first floor, although a large doorway has been inserted under a modern steel joist. A local resident remembers this being used as a garage, although it is likely that it had a previous use.

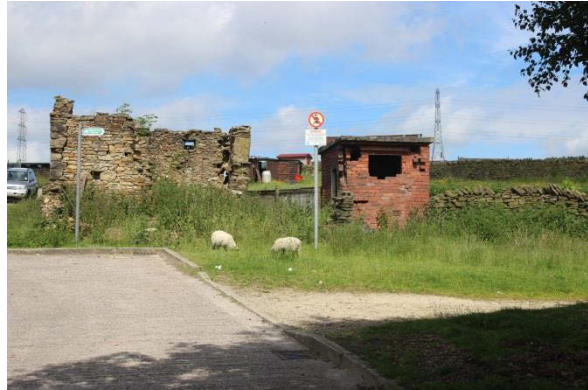
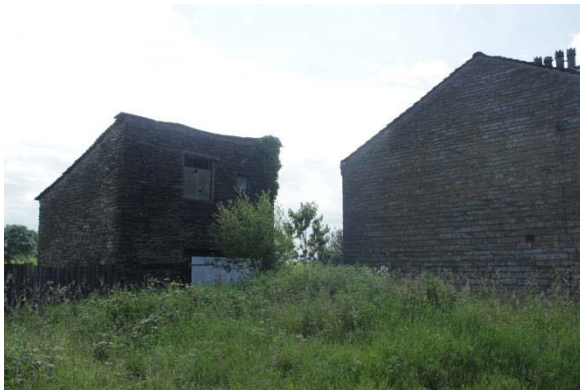
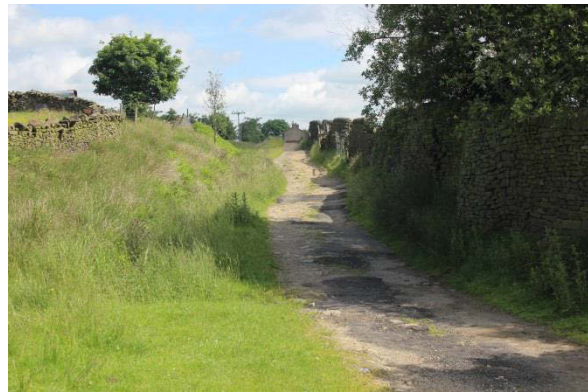
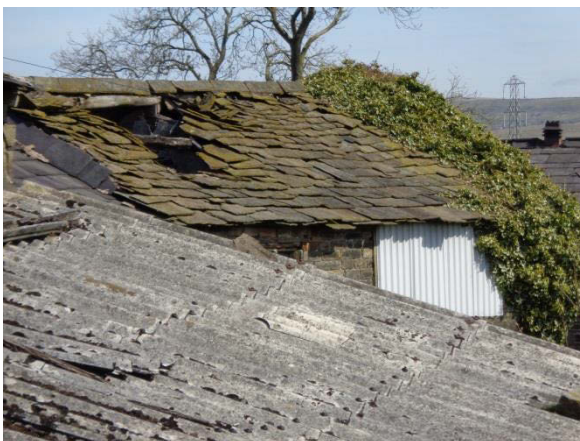
Even though the majority of structures in the hamlet are in active use, there are some historic buildings that are deteriorating including the barn at the Grade II listed Smallshaw Farm which has a collapsing roof and the brick building above which appears to have been an electric substation.

Some unadopted roads are poorly maintained and deteriorating.

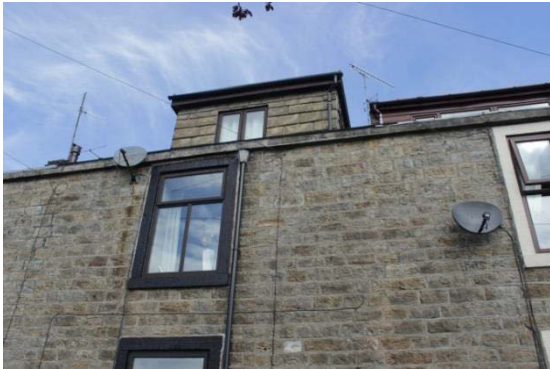
Dormers on historic terraces

A number of dormers have been built on terraces on Smallshaw Road. These detract from the historic character of the buildings.

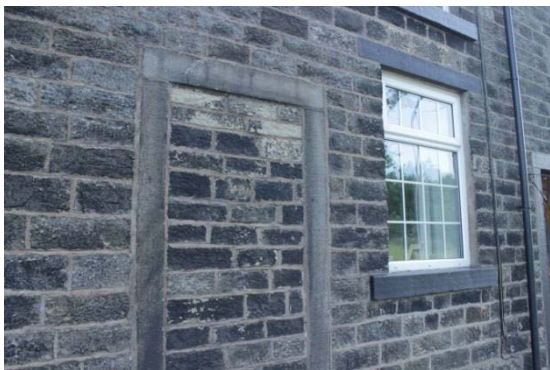
It is increasingly typical to see uPVC windows used on historic buildings. This modern material harms the character of a conservation area, particularly when the configuration is different to the original windows.

Use of uPVC windows

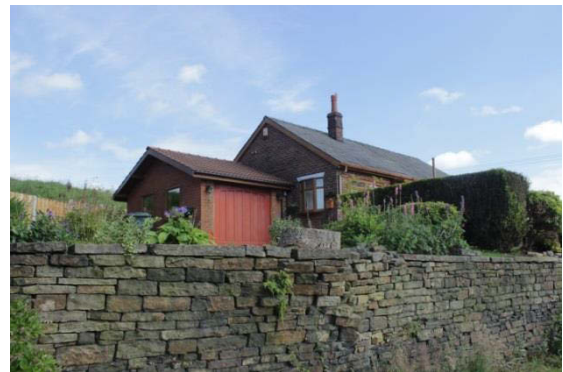
However, there is also one modern dwelling on Smallshaw Road constructed from red brick which is out of character with the vernacular of the hamlet.

A modern red brick building
